THE  
ECCLESIASTICAL  
ARCHITECTURE  
OF SCOTLAND

FROM THE EARLIEST CHRISTIAN TIMES TO THE  
SEVENTEENTH CENTURY

BY  
DAVID MACGIBBON AND THOMAS ROSS  
AUTHORS OF "THE CASTELLATED AND DOMESTIC ARCHITECTURE OF SCOTLAND"

VOLUME ONE

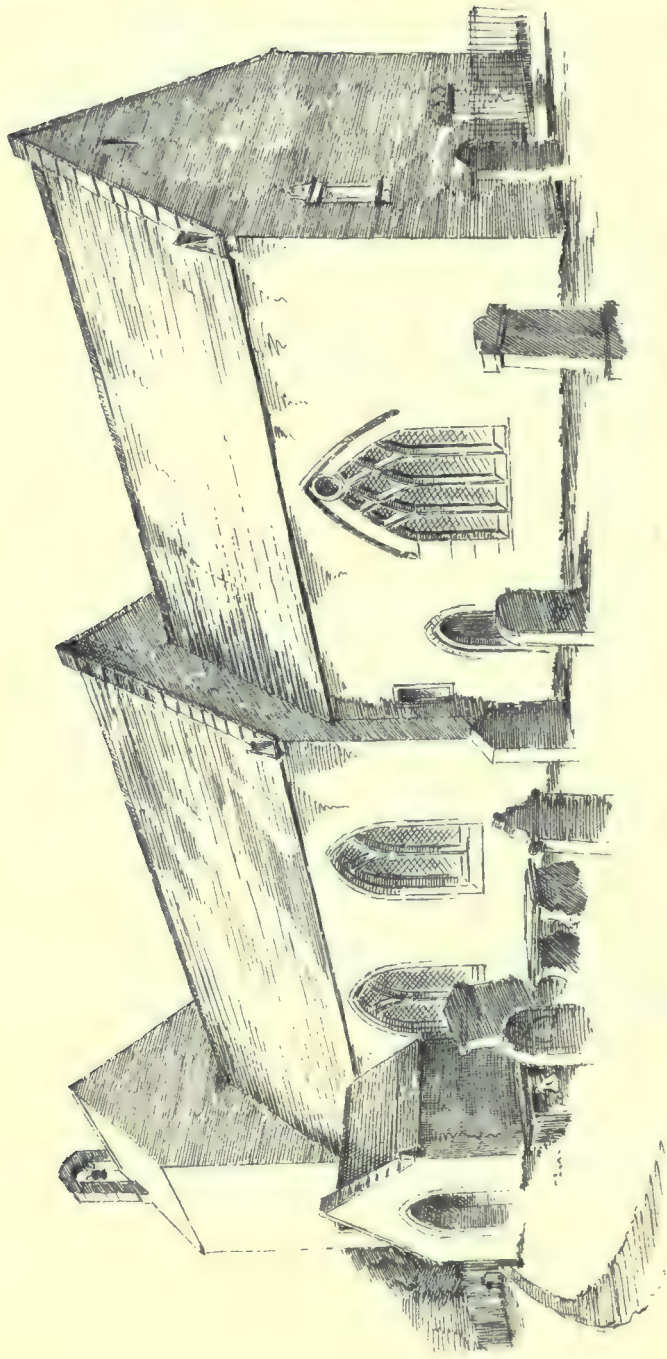
FIG. 288.—Stobo Church. View from South-East.

As the whole building is harled or rough cast on the outside and plastered on the inside, it is impossible to say definitely whether the tower is Norman or later. The work of the sixteenth and seventeenth centuries consists of the south porch (Fig. 288), built up against the Norman doorway (Fig. 289), and a north aisle or chapel, which opened from the nave

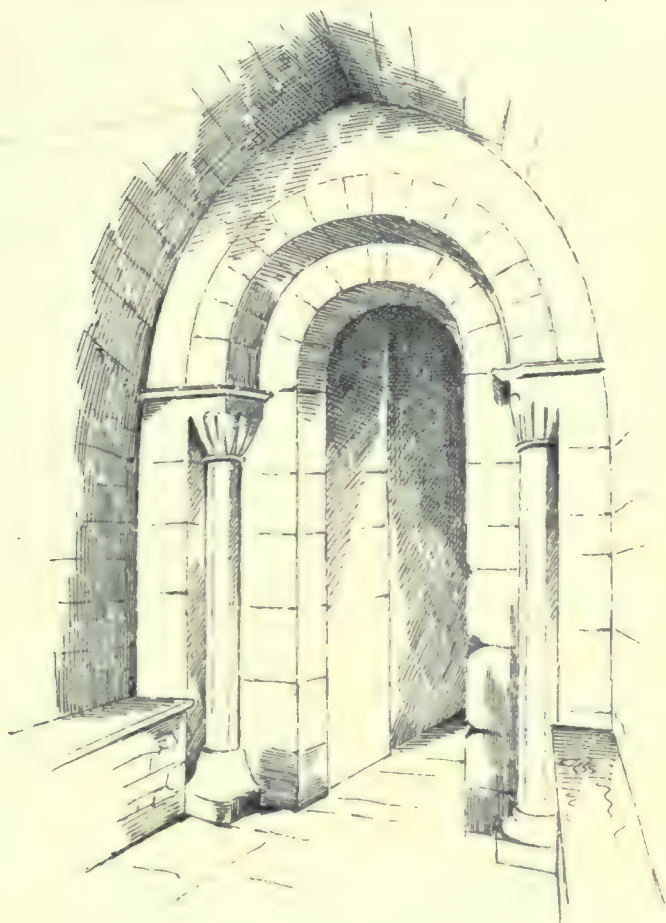
FIG. 280.—Stobo Church. Norman Doorway.

The original windows in the north side of the chancel remain. The daylight is about 7 inches wide by about 2 feet high. There has been a Norman doorway in the north side of the nave. It has a plain arch, and was probably not unlike the doorway in the opposite wall, which is of very simple design, with octagonal shafts. The capitals are slightly mutilated.

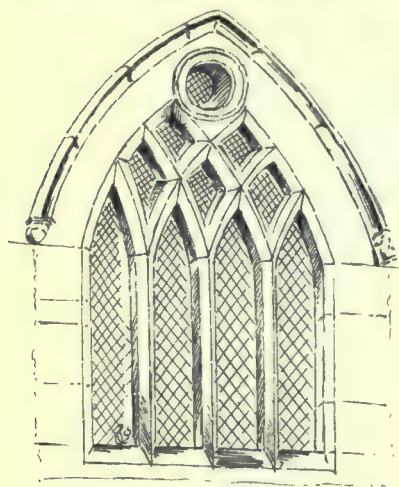
FIG. 290. - Stobo Church. Window in South Wall of Chancel.

with a round arch, now built up. This chapel, which is ruined, was barrel vaulted. The windows in the south wall are also of this period. The mullions and tracery of those of the nave are modern, as is also a monument erected against the interior of the east wall, which may possibly conceal a Norman east window. The four-light window in the south wall of the chancel (Fig. 290), although of this late period, is quaint and pleasing, the small circle in the apex giving it quite a touch of originality.

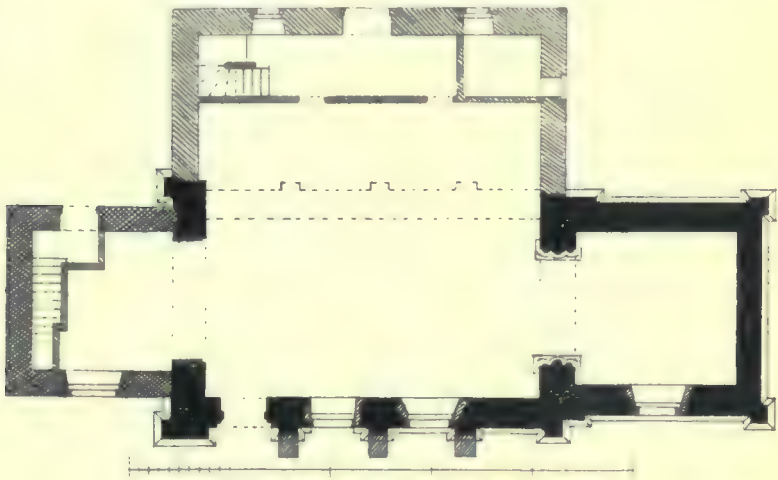
FIG. 291.—Duddingston Church. Plan.

The nave (Fig. 291) measures about 33 feet 4 inches long, and was probably about 19 feet wide inside. The chancel is about square, being 16 feet  $1\frac{1}{2}$  inch from east to west by 15 feet 6 inches wide, the total inside length of the church being 52 feet 9 inches.

The north wall of the nave has been taken down and a north aisle added (see Plan), apparently in the year 1631, as that date (Fig. 297) is carved on a window lintel of the east wall. In the north gable of this aisle there are two traceried windows, somewhat after the style of the Perpendicular Period. (Fig. 298.) It will be observed that the mouldings of the loop form of the tracery do not mitre with the arch mouldings.

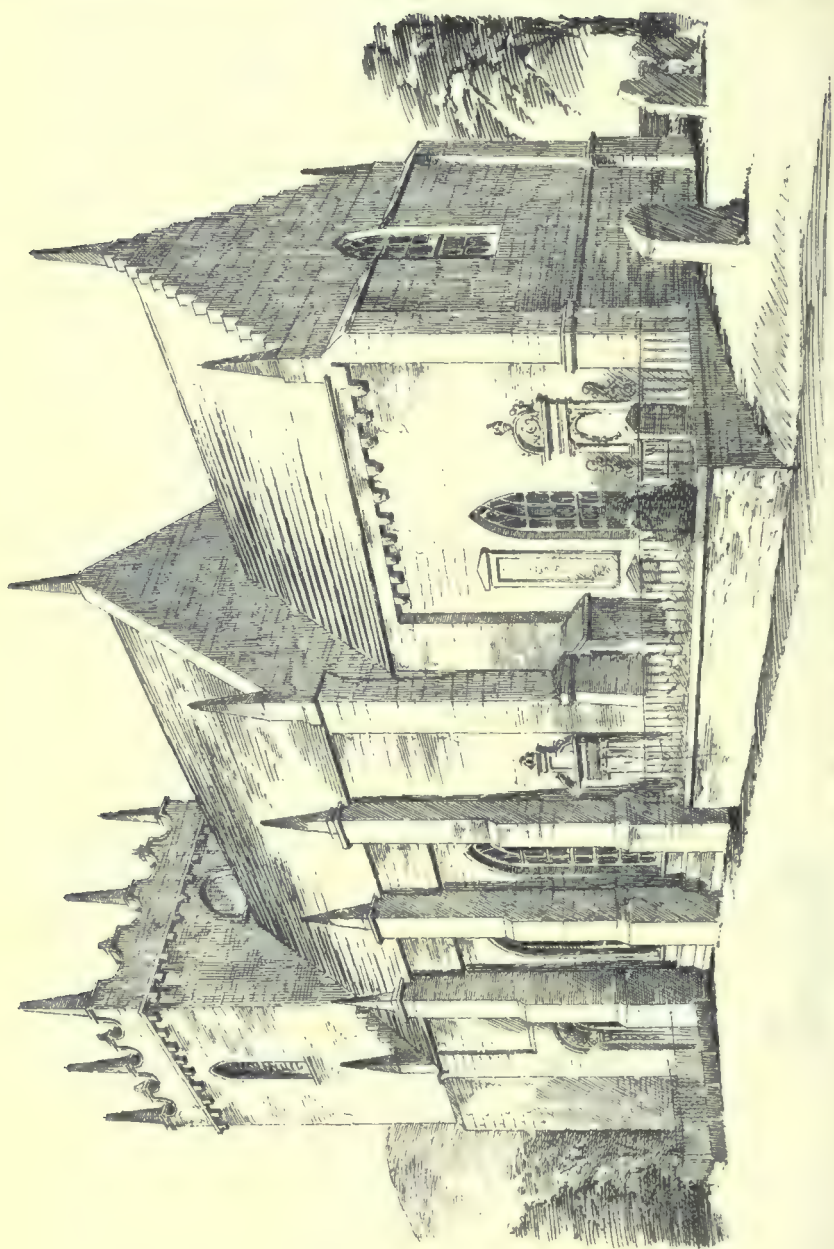
FIG. 292.—Duddingston Church. From South-East.

On the outside a series of pilaster buttresses divided the nave into four bays; these still exist along the south side, measuring about 2 feet on the face, and having a projection of 9 inches, with a large base returned round them. To these pilasters massive buttresses (Fig. 292) projecting three feet have been added. At the corners of the church the original angle pilasters remain unaltered. The old doorway in the west bay of the south side (Fig. 293) still continues unchanged, except that it

On the exterior of the chancel there occur on the north and south sides (see Fig. 292) characteristic Norman corbels supporting the wall-head parapet. These consist generally of the usual bridled heads and monstrous faces, but they are now very weather-worn.

present windows, seen in Fig. 292, were inserted. The original windows were, doubtless, the usual small windows found in Norman churches, and when they came to be enlarged, the builders probably increased the buttresses to compensate for the weakening of the wall, and added the conical finials on them and on the gables (see Fig. 292). It is obvious that to this period also the upper part of the tower belongs. The lower part of the tower, although not of the original structure, is, we are inclined to think, of considerable antiquity; it opens into the church with a plain, round arch. The staircase shown in it and on the north aisle lead to galleries.

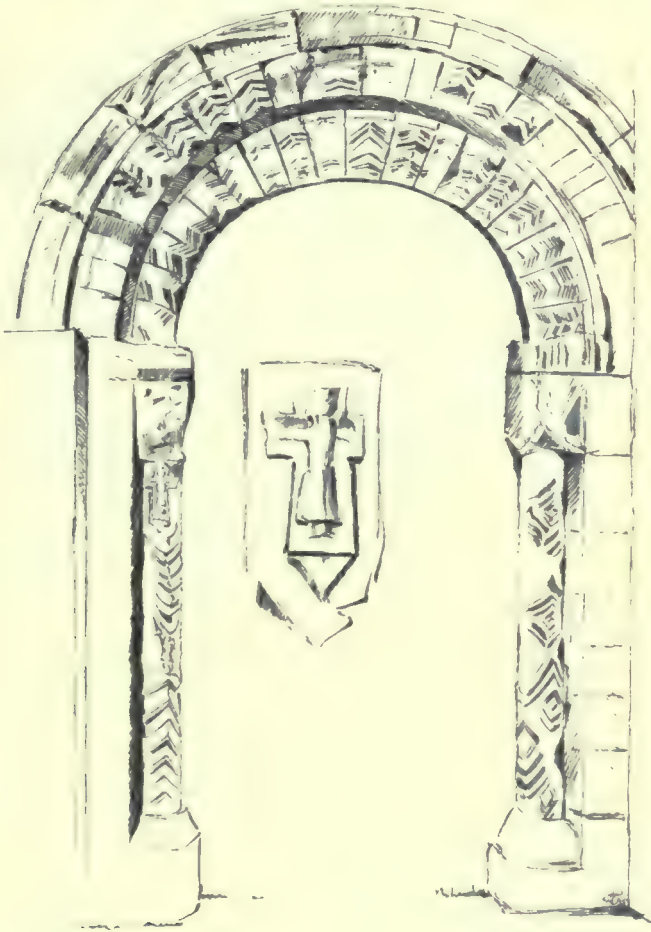
FIG. 293.—Duddingston Church. South Doorway.

is built up, and has an incongruous granite slab occupying the whole space. The opening of the doorway is about 4 feet 2 inches wide. The arch is richly sculptured with the chevron in two orders, the inner order being supported on shafts decorated with the chevron in a manner not found, we think, anywhere else in Scotland. On one of these shafts there are two sculptured scenes. The upper one represents the Crucifixion. (See Fig. 293.) The lower one (Fig. 294) shows a figure holding aloft a drawn sword; beside the sword, in the shade where the shaft disappears at the jamb, there is what looks like a key, possibly the symbol of St. Peter, so that the subject may be the incident of cutting off the ear of the High Priest.

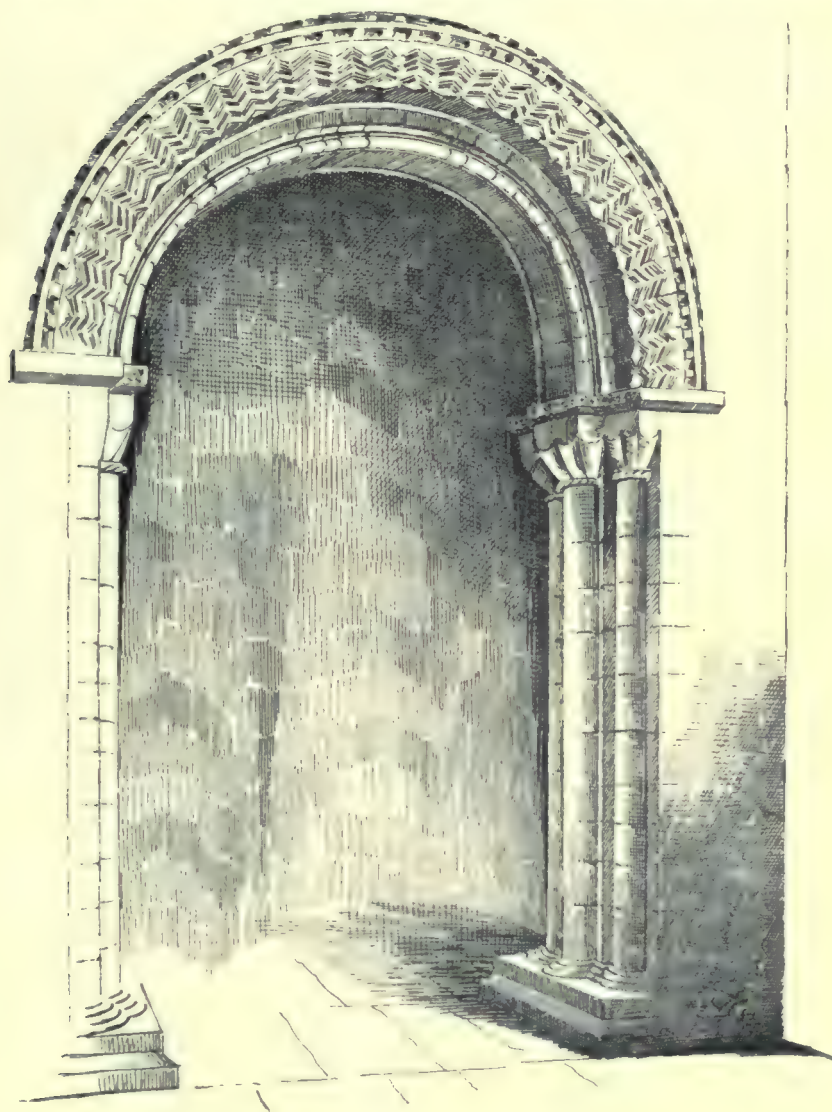
FIG. 295.—Duddingston Church. Chancel Arch.

The chancel arch (Fig. 295) is the only Norman feature now remaining in the interior. It is in two orders, having on the outer order the usual chevron ornament, with a notched hood moulding similar to what is found at Dunfermline. The inner order has a bold bead on the edge.

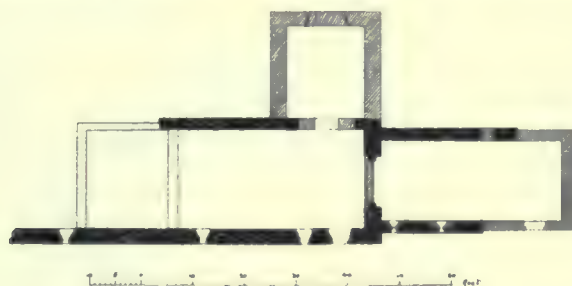
FIG. 299.—Gullane Church. Plan.

The structure (Fig. 299) consisted of nave and chancel, the chancel being entered from the nave by a semicircular chancel arch, almost the only remnant of the edifice of the twelfth century which survives.

The chancel as it now stands is 35 feet in length by 15 feet 6 inches in width internally. The eastern portion is a comparatively recent addition, and has a square east wall, but it is believed that the chancel formerly terminated towards the east with an apse. Part of the old south wall of the chancel, extending to about 20 feet in length, still remains. It contains two pointed windows, with late mouldings on the exterior, probably fragments of the restoration of the fifteenth century, at the time when the church was made collegiate. These windows have been reduced to mere slits by being built up with slabs in the interior. This filling up was probably inserted when the place was converted into a burial-ground for a private family, in order to prevent entrance through the windows.

The south wall of the nave is still about 72 feet in length, but the north wall is reduced to about 43 feet long. The west end is gone, and the nave has been divided up into private burial-places. The windows which remain in the south wall of the nave have been much altered in Presbyterian times, having had flat lintels, &c., introduced.

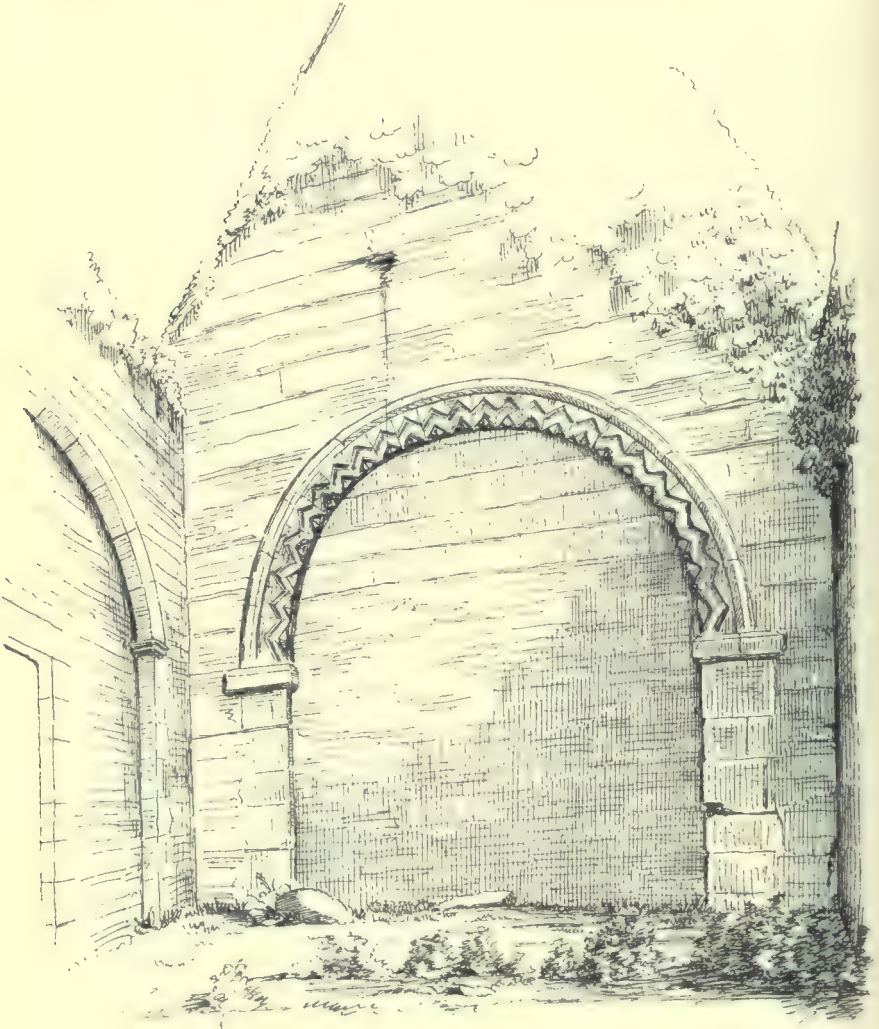
FIG. 300.—Gullane Church. West Side of Chancel Arch.

The chancel archway (Figs. 300, 301) is 8 feet in width. It has square jambs on both sides of the wall, and a central half shaft on each jamb of the opening. The caps of these shafts (see Fig. 301) are fairly preserved, and

The arch has been built up, but the two plain orders of the east side are visible, and the outer order on the west side (Fig. 300), carved with a bold chevron and finished with a three-sided hood, is well preserved. There can be no doubt as to this part of the structure being of Norman origin, and the north wall of the nave has a three-sided string course, which seems to indicate the same date, but the remainder of the structure

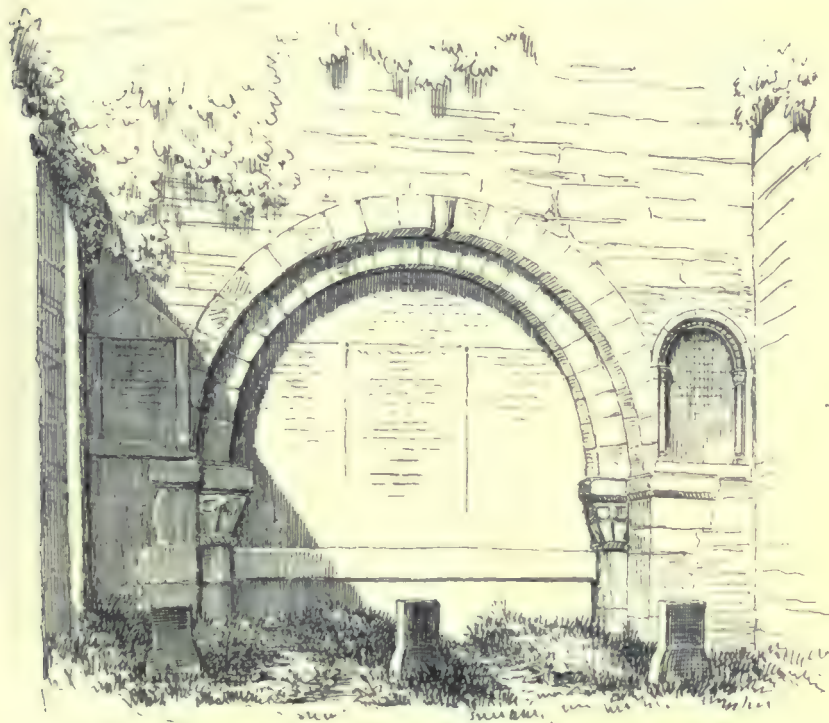
FIG. 301.—Gullane Church. East Side of Chancel Arch.

show a form of volutes, with a cabled necking and a three-sided abacus, which was continued as a string course along the walls on each side.

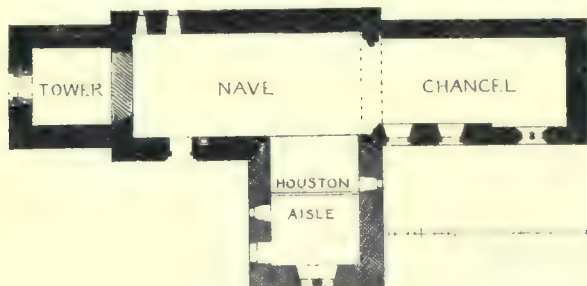
FIG. 302.—Uphall Church. Plan.

alterations and extensions, but the original plan is still perfectly clear, and is shown by Fig. 302, which ignores the changes, except the addition of the south aisle or wing. The building has no side aisles.

The nave measures about 35 feet long by 15 feet wide, and the

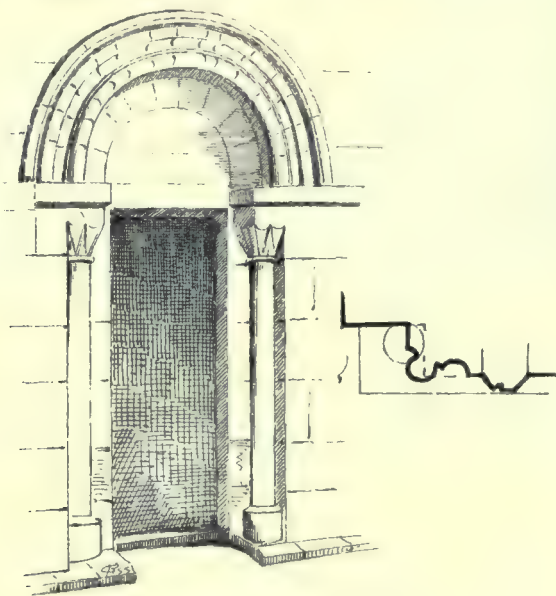
FIG. 303.—Uphall Church. Doorway.

chancel 30 feet 6 inches long by 13 feet wide. The doorway (Fig. 303) is in the usual place at the west end of the south front. It is of Norman design, having a nook shaft at each side, with cushion cap and plain square abacus. The arch is round, and has two orders, the inner order being square edged, and the outer composed of mouldings, and having a moulded label. It is probable there was some piece of carving beneath the arch, or else the square lintel is an alteration. A stoup adjoining in the south wall has a pointed opening, and probably dates from the fifteenth century. There is another doorway opposite in the north wall, which is perfectly plain, and, so far as it can be seen, it appears to be original; but, as the lower parts of the walls are covered with wood boarding, other requisites which may exist, such as ambries and piscina, are concealed. None of the windows are original, so far, at least, as they are seen on the exterior, and the whole masonry on the inside is covered. The east window in the south wall (Fig. 304) has a horizontal arched lintel, with radiating joints, and probably dates from late in the fifteenth century. It is impossible to say whether there were windows in the east wall or not, and, as regards the north wall, it has nearly all been taken down between the west door and the chancel arch, in order to admit a modern addition. The chancel arch itself has been taken away, and the wall above removed, and the place occupied by it has been filled up with lath and plaster, and slated on the outside.

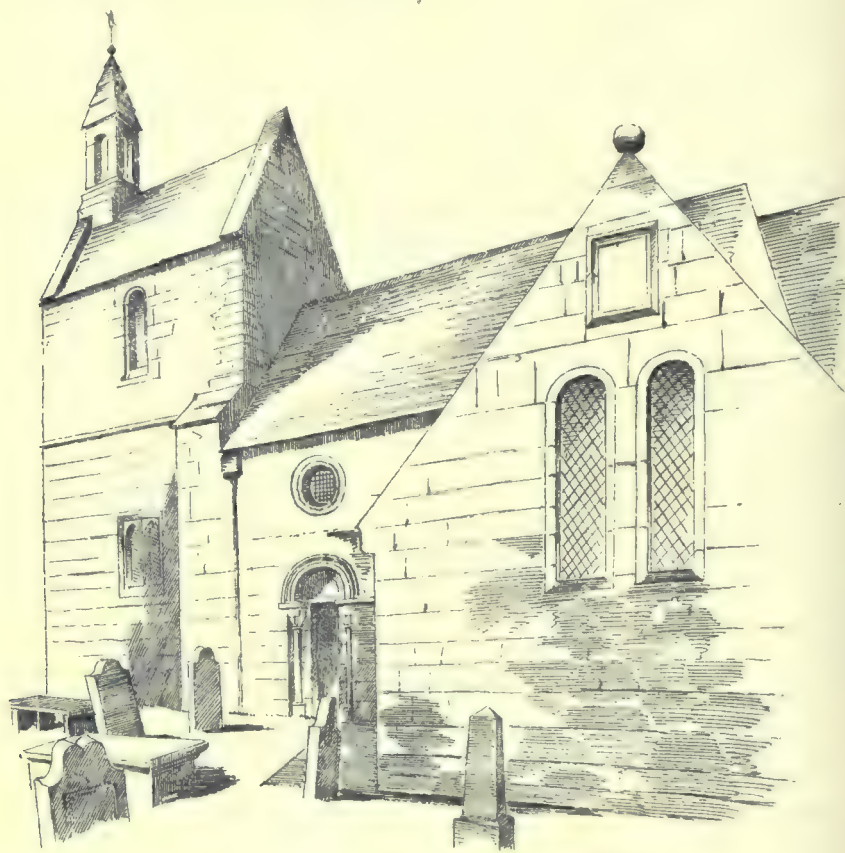
FIG. 305.—Uphall Church. Western Tower and South Wing.

The western tower (Fig. 305) has been appropriated as the burial-place of the Buchan family; so that it now forms no part of the church. It is entered by a fanciful Norman door in the west end. The windows in the tower are all modern, and so, we need hardly say, is the belfry. The upper part of the tower has been rebuilt at a late period, probably during the fifteenth century alteration.

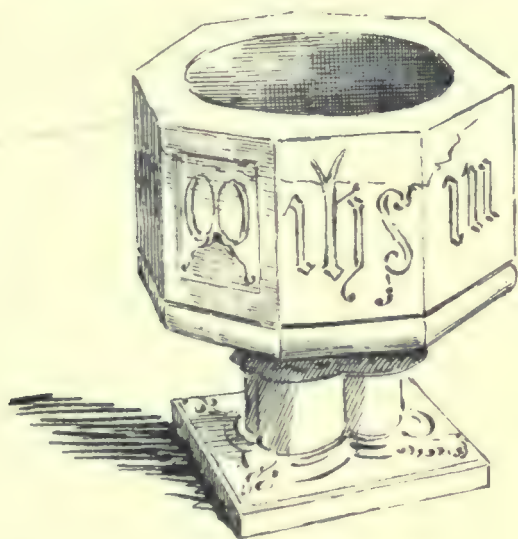
FIG. 306.—Strathbroc Church. Font.

Of the Church of Strathbroc only two relics now remain. The one is the font (Fig. 306), of which the basin only is old. It was rescued from the adjoining farm steading, where it served a useful, if not dignified, purpose, and placed on its present base, and now stands in the Roman Catholic Church of Broxburn. It is octagonal in shape, and contains (Fig. 307) the letters M. and IHS., repeated twice. Two of the faces bear the inscriptions

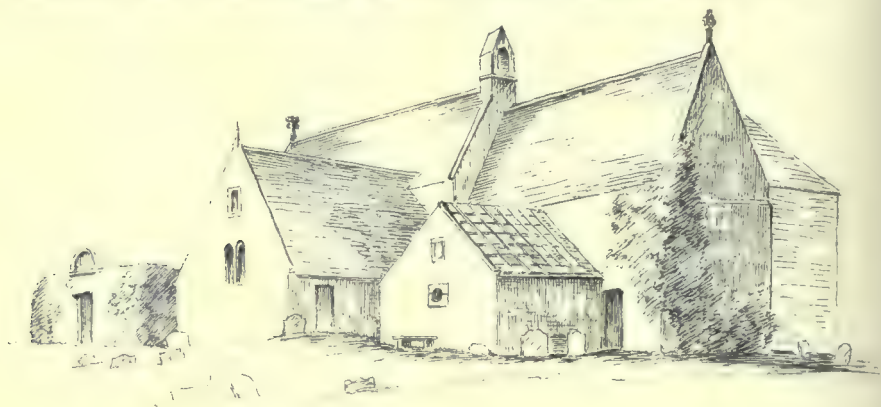
FIG. 309.—Abercorn Church. From South-East.

since Reformation times. (Fig. 309.) These can generally be identified by the coats of arms they bear.

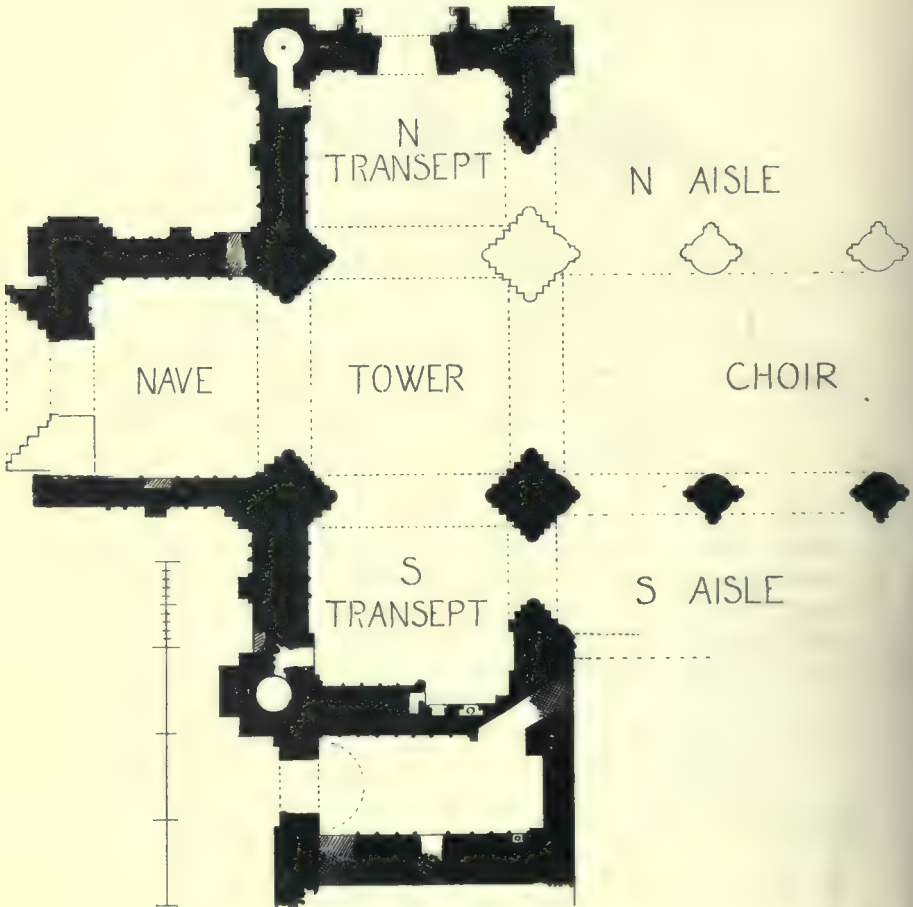
FIG. 311.—Kelso Abbey. Ground Plan.

The edifice has consisted (Fig. 311) of a choir or chancel of considerable length, with north and south aisles, and of a transept and nave, without aisles. The north and south divisions of the transept and the nave form three arms of equal length round the three sides of the crossing, above which rises the massive square tower.

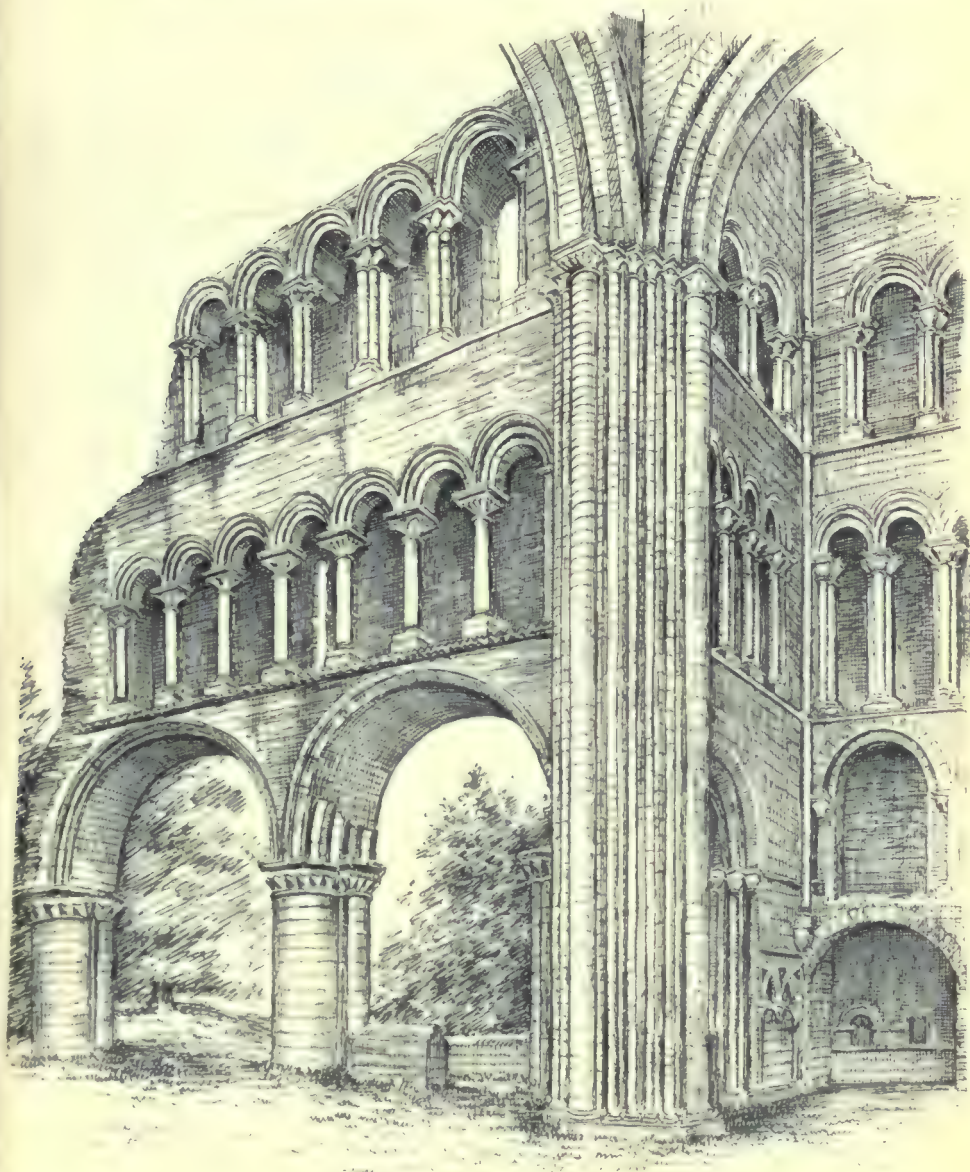
FIG. 312.—Kelso Abbey. South Side of Chancel and South Transept.

A portion of each of the departments of the church survives, but in the case of the chancel there remains only a fragment. The chancel is the only part which had aisles, but these have now entirely disappeared; and of the chancel itself, all that remains (Fig. 312) is two of the south main piers, with their arches, and two stories of arcades above, which represent the triforium and clerestory. This arrangement is peculiar, and the effect is striking.

The piers are designed as a series of shafts set in square nooks (four on each of the complete sides), with a larger semicircular shaft at each angle. (See Figs. 312 and 314.) The shafts are all built in courses with the piers. They have transition bases and caps. From

A recess for a tomb is seen in the south wall of the transept (see Fig. 312), and in the recess beneath there are two ambries or lockers and a piscina, the only one remaining in the building.

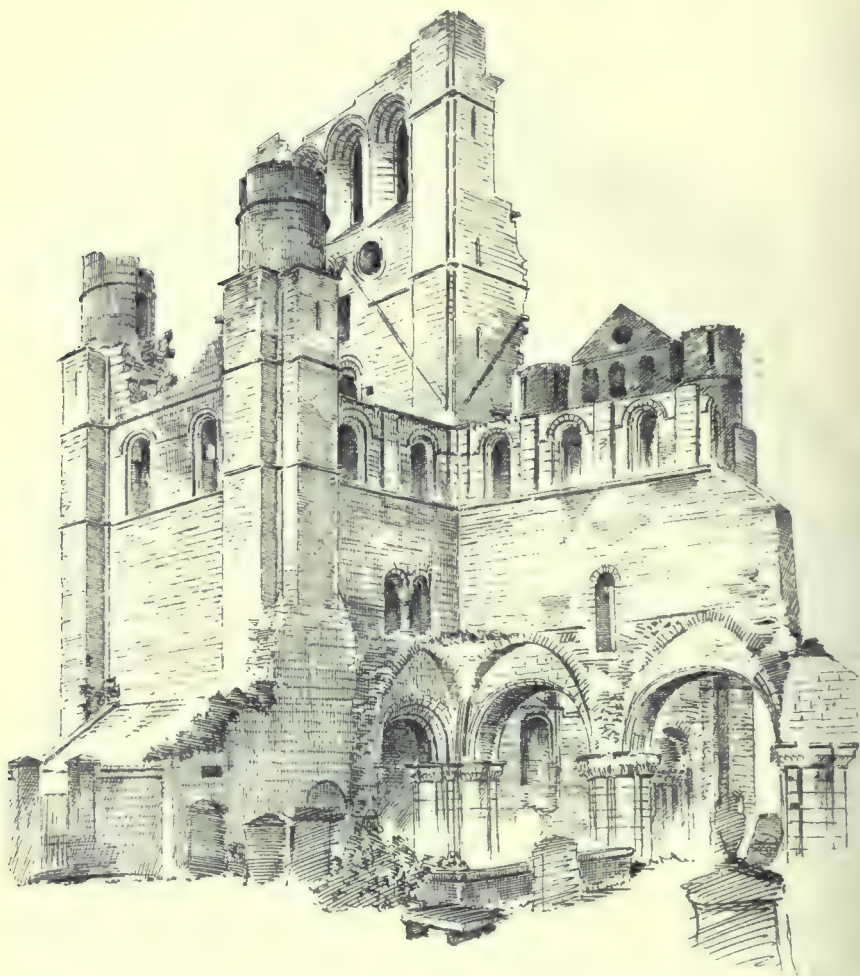
FIG. 313.—Kelso Abbey. From South-East.

In the view of the exterior of this portion of the choir (Fig. 313), the outside of the windows of the clerestory is visible, being simple round-headed openings, with flat buttresses between them. The remainder of the wall is plain, but, judging from the level of the triforium window, the vaulting of the aisle, which was very high, and partly covered the windows, seems to have been added at a later date. The choir was 28 feet in width from centre to centre of the piers, only two of which survive.

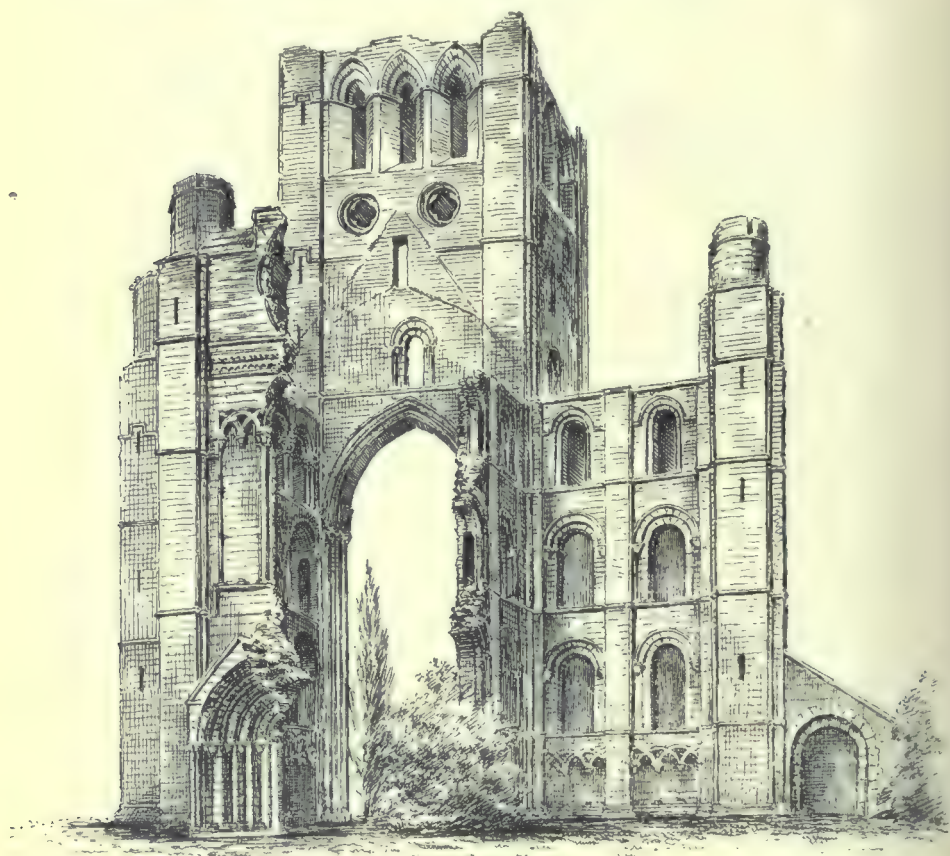
FIG. 315.—Kelso Abbey. From West.

very unusual arrangement, the western arm or nave being generally much the longest division of the church. We have not heard any satisfactory explanation given of the shortness of the nave of Kelso. This arrangement of plan has apparently been part of the original design, as the western doorway (Figs. 315 and 316) is one of the most prominently Norman portions of the edifice. The upper part of the west front (see

Fig. 315), although much broken away, has been in the transition style; while the Norman arcading, which runs round the interior of the nave, was continued across the west end.

In the façades of the west end and north transept the windows of the different stories have been grouped so as to form distinct designs. In the west end, over the great west doorway (see Fig. 315), there has been an arrangement of tall windows of apparently lancet form, having on either side an interlacing arcade of round arches, supported

on tall banded shafts. This is now, unfortunately, greatly destroyed. Above the arcade there runs a horizontal flat cornice, enriched with several rows of carved ornaments, and this was surmounted by a large opening of quatrefoil shape, surrounded with numerous mouldings and enrichments. The angle buttresses have been crowned with octagonal turrets.

The nave and the north and south transept each measure about 22 feet in width by 18 feet in length. Each contains four stories in height (Figs. 315 and 317), consisting of an interlacing arcade of Norman work in the interior of the ground level, and three stories of windows above. The upper arcades of the choir do not extend round the nave and transepts, except in a portion of the south transept. (See Fig. 312.) Another arrangement was found desirable in those portions where there were no aisles, as windows could be obtained in that case; while, with aisles (as in the choir), the first floor was darkened by the roof of the

aisles. The windows in the different stories of the nave and transept have all round arches, both outside (see Fig. 315) and inside, the former having one plain square-edged order supported on nook shafts. Of these the caps and bases only are now for the most part in existence. The exterior is marked at each angle by broad and shallow Norman buttresses, with nook shafts in the angles, and an interlacing arcade running round the lower story, both internally and externally.

ing. The former is a remarkably rich specimen of the elaborate carved work which characterised the late Norman period. Unfortunately, the south half of this door-piece has perished. But, from what remains (see Fig. 315), it is evident that it consisted of a large door-piece, or quasi-porch, projecting upwards of 5 feet, and finished with a sloping gable, with

The tower (see Figs. 315 and 320), of which the south and west sides and a small portion of the north and east sides remain, is 35 feet square over the walls. It is carried up with plain masonry externally, but the interior has immediately over the great arches of the crossing an arcade of round moulded arches, supported on triple shafts similar to those of the choir. Above this arcade is another story containing simple round arched openings, which are lighted on the exterior by circular windows containing quatrefoils. Over this tier is the top story, which contains three pointed and deeply-recessed windows on each side of the tower. Broad flat buttresses are placed at each angle of the tower, similar to those of the main building, and these were, no doubt, originally finished with turrets like those of the transepts.

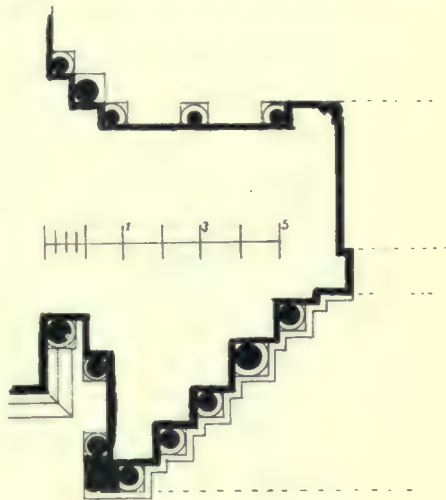
FIG. 316.—Kelso Abbey. West Doorway.

stone roof. The jambs (see Fig. 316) contained five detached shafts set in nooks, and having Norman bases and carved caps. Over each of these shafts there springs a circular order, carved with rich Norman ornament, now, however, very much decayed. The jambs of the doorway also formed moulded shafts, supporting their order in the arch.

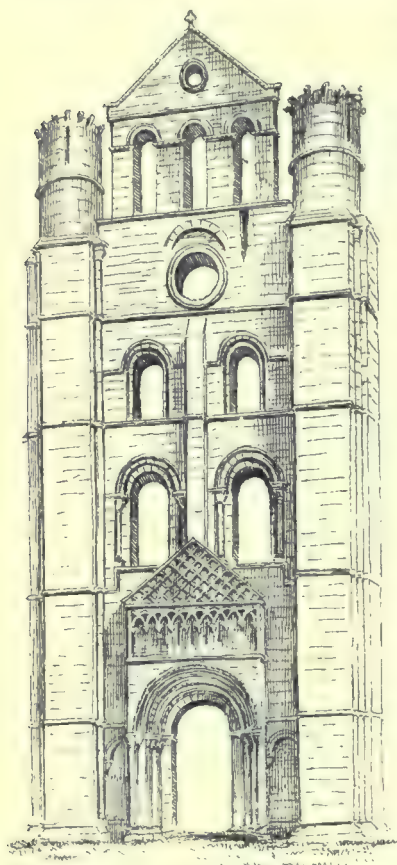
FIG. 317. — Kelso Abbey.  
North End of Transept.

The north wall of the north transept (see Fig. 317) has a fine transition door-piece (Fig. 318), which occupies the two lower stories. The next two stories have two windows in each, separated by a small buttress, the upper one of these stories having three arches in the interior. (See Fig. 314.) Above these stories is a small circular window, with a curious saving arch over it, and the whole is crowned with a top story,

containing three round-headed openings, and a gable with a small circular aperture. The buttresses at the angles are crowned with circular turrets, which have been finished with a projecting parapet, the corbels for carrying which still survive. The upper part of the gable shows signs of having been altered.

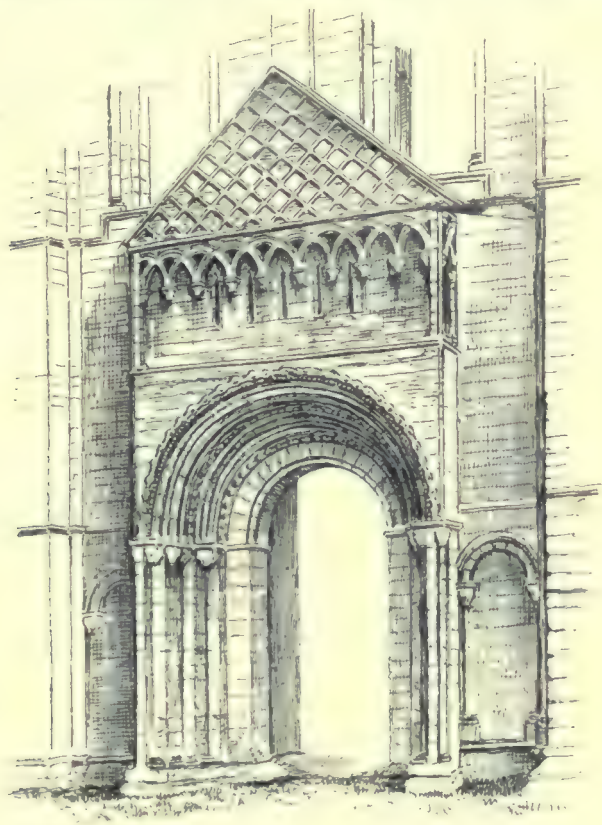
FIG. 313.—Kelso Abbey. Doorway of North Transept.

The door-piece in the north wall of the transept (see Fig. 318) is also

a prominent feature. It projects about 4 feet 6 inches from the main wall, is carried up two stories, and is roofed in with a sloping stone roof.

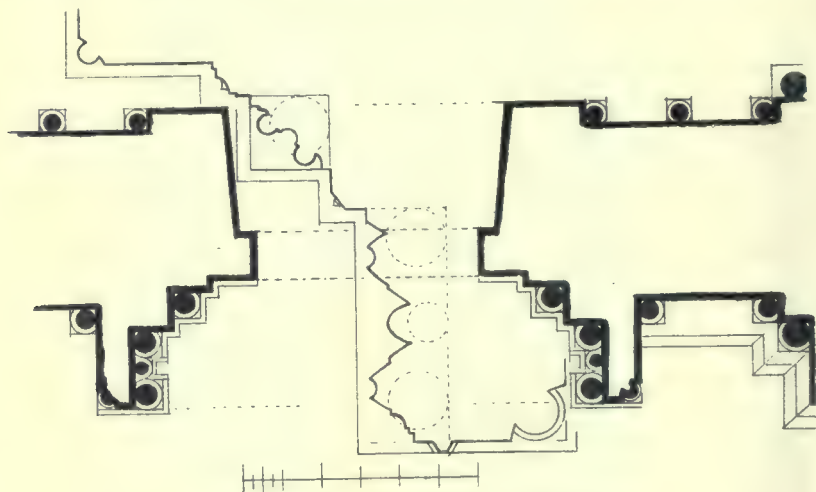
FIG. 319.—Kelso Abbey. Plan of Doorway in North Transept.

The lower story contains the doorway (Fig. 319), which is 5 feet 6 inches wide, and has plain jambs. It is set back about 3 feet 6 inches, and the ingoing for about 2 feet is square, and contains two shafts of ordinary size, with a small one between them; then follows a nook containing a shaft, and then the jamb. The shafts have the usual Norman caps and bases. The mouldings of the arch (see enlarged outline in Fig. 319) are peculiar in their profile. They are enriched—the outer one with small medallions, the central one with the billet, and the inner one with rosettes. Above the archway there is an arcade of interlacing round arches, the shafts, which are gone, having Norman caps. The tympanum of the gable is covered with a reticulation of round beads or rolls.

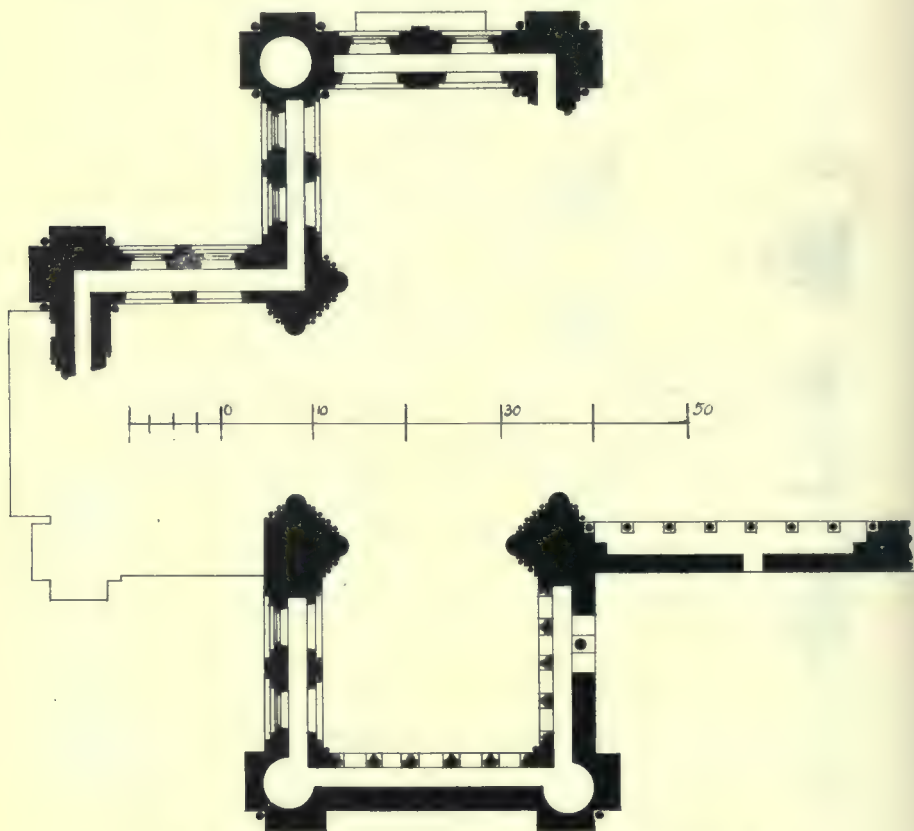
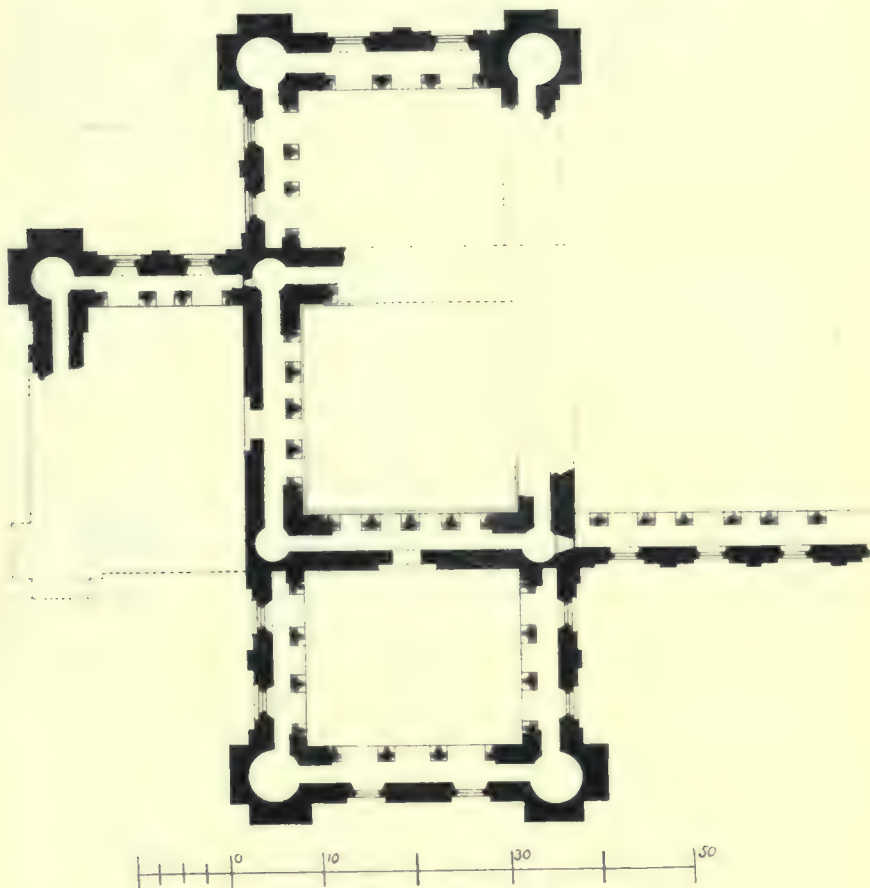
The approach to the upper floors is now by one staircase in the north-west angle of the transept, but there were, doubtless, other similar staircases in parts of the structure now removed. This staircase gives access to passages which run round the building on every floor (Figs. 321 and 322) between the arcades and the outer walls. In the angles of the tower there are small wheel stairs leading to every floor, and passages running round the tower on every story (Fig. 323.) These arcades and passages have tended to weaken the structure, which it has been found necessary to strengthen with numerous iron tie-rods, iron beams, &c.

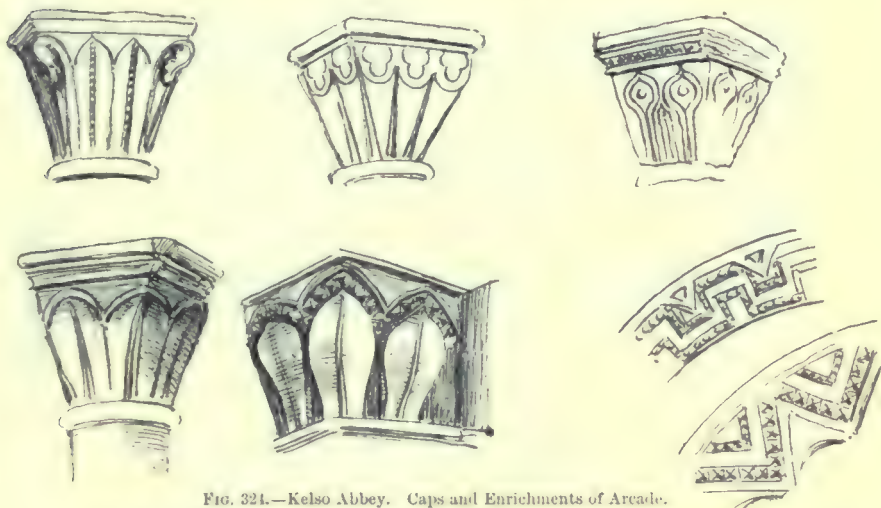
FIG. 324.—Kelso Abbey. Caps and Enrichments of Arcade.

The style of the caps of the arcade on the ground floor (Fig. 324) is somewhat florid and unusual. The interlacing arches are also in some places much carved and ornamented, and some portions are wonderfully well preserved.

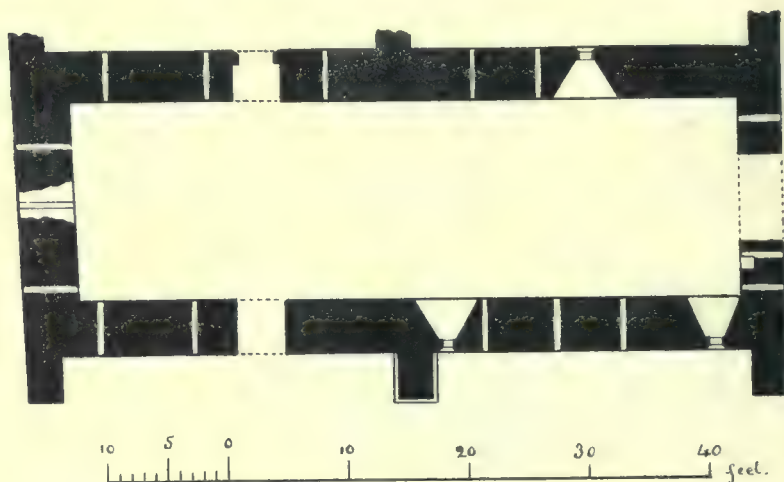
FIG. 325.—St. Martin's, Haddington. Plan.

It is a simple oblong (Fig. 325), 55 feet in length by 16 feet 6 inches in width internally, and appears originally to have had no buttresses; but several have been added at a later date. The side walls are 4 feet 6 inches in thickness, but do not appear to have been sufficiently strong

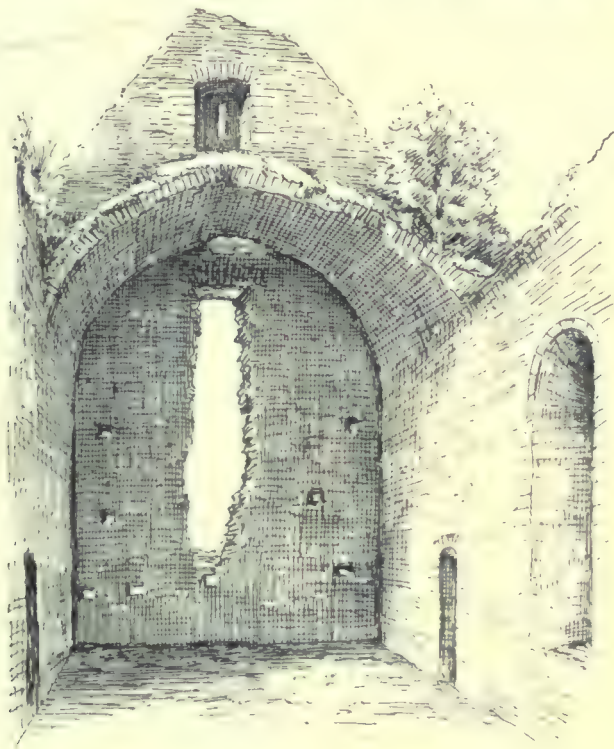
FIG. 326.—St. Martin's, Haddington. Interior of West End.

to resist the thrust of the barrel vault with which the building was covered, and a portion of which (Fig. 326) still exists.
